R.E.I. & Co Home Inspections

Commercial Inspection Report

5528 55 Avenue, Edmonton, Alberta
Inspection prepared for: Company 1234 & John Doe
Date of Inspection: 4/27/2022 Time: 10:30 am
Age of Home: 2001 Size: 17000 Sqft
Weather: Raining and 5 Degrees

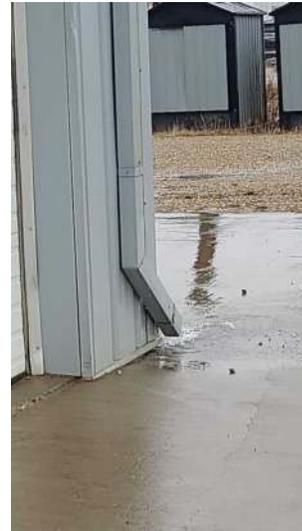
Debris blocked downspouts observed, suggest cleaning gutters and downspouts, which should be a regular part of maintenance.

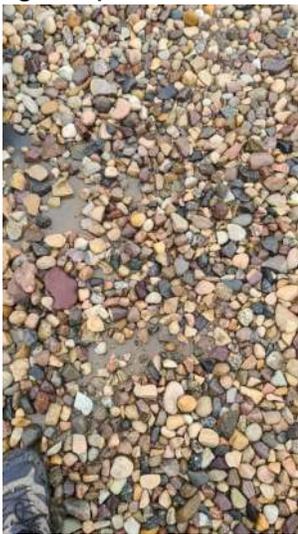
Debris blocked downspouts observed, suggest cleaning gutters and downspouts, which should be a regular part of maintenance.

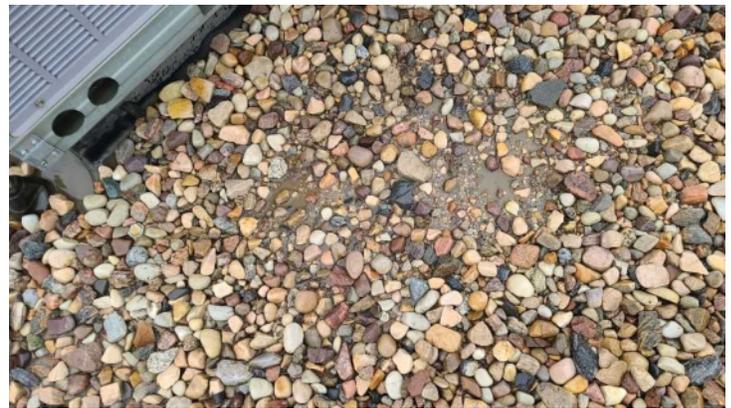
Debris blocked downspouts observed, suggest cleaning gutters and downspouts, which should be a regular part of maintenance.

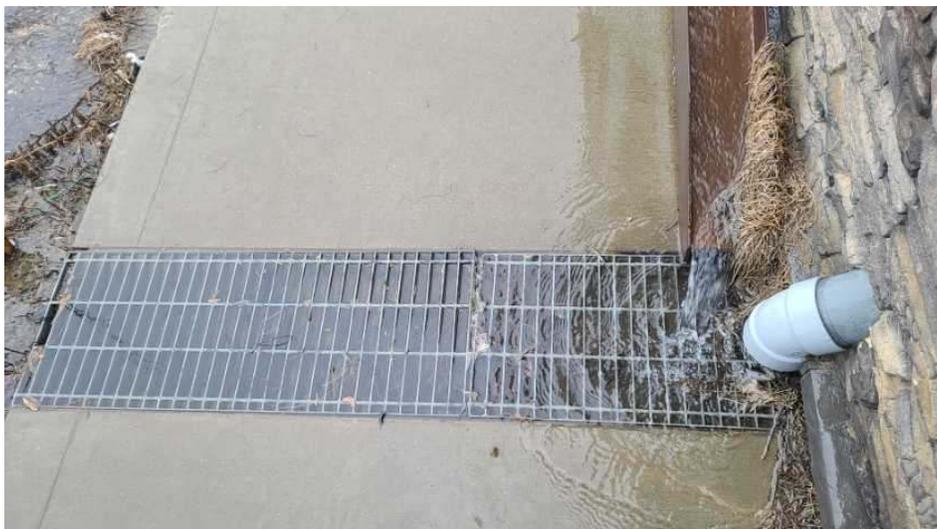
Debris blocked downspouts observed, suggest cleaning gutters and downspouts, which should be a regular part of maintenance.

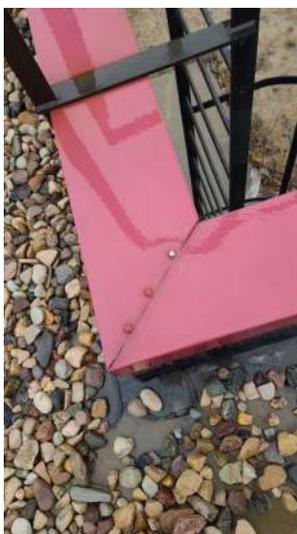
There are joints that need to be monitored for moisture penetration.

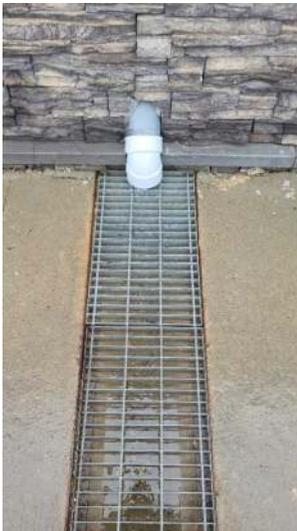
The drainage swales are clogged and leaking back towards the building, there are high levels of moisture in the concrete floor inside the building. Have a contractor evaluate and service as needed.

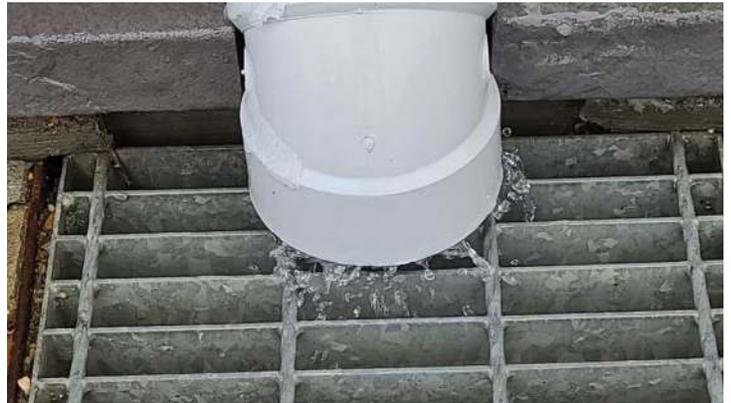
The drainage swales are clogged and leaking back towards the building, there are high levels of moisture in the concrete floor inside the building. Have a contractor evaluate and service as needed.

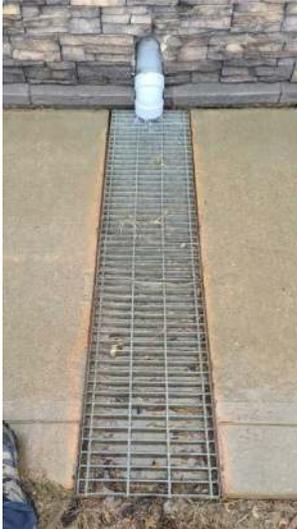
The drainage swales are clogged and leaking back towards the building, there are high levels of moisture in the concrete floor inside the building. Have a contractor evaluate and service as needed.

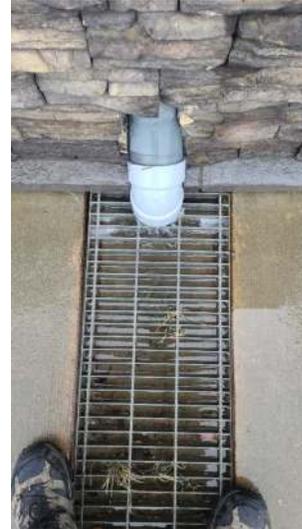
The drainage swales are clogged and leaking back towards the building, there are high levels of moisture in the concrete floor inside the building. Have a contractor evaluate and service as needed.

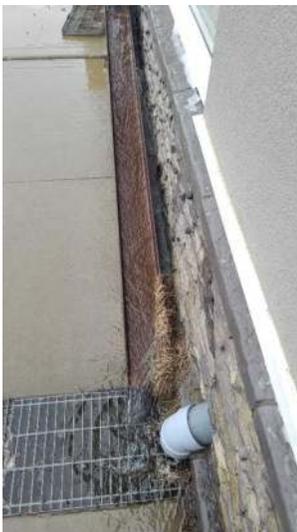
The drainage swales are clogged and leaking back towards the building, there are high levels of moisture in the concrete floor inside the building. Have a contractor evaluate and service as needed.

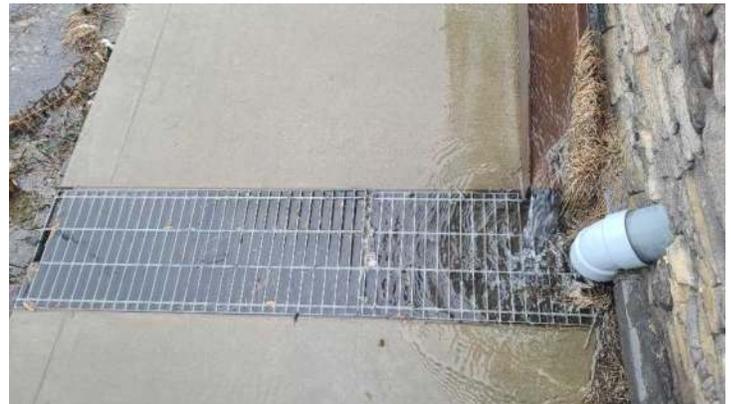
The drainage swales are clogged and leaking back towards the building, there are high levels of moisture in the concrete floor inside the building. Have a contractor evaluate and service as needed.

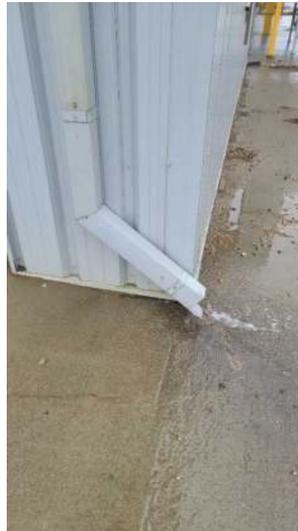
The storm water around the building needs to be evaluated by a contractor and serviced as needed.

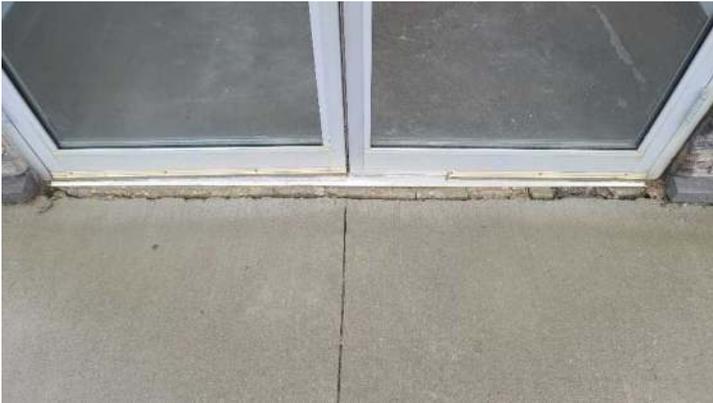
The sidewalks have typical cracks that indicate movement of the base under the sidewalk, water management needs to be addressed to control movement. If this is left it can effect the components of the building and surrounding areas.

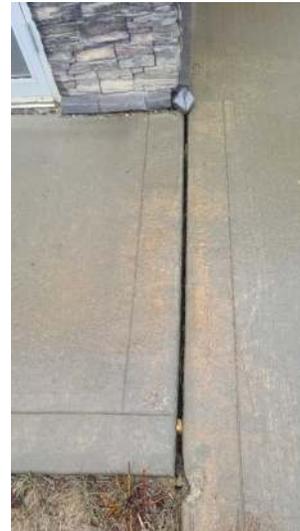
The sidewalks have typical cracks that indicate movement of the base under the sidewalk, water management needs to be addressed to control movement. If this is left it can effect the components of the building and surrounding areas.

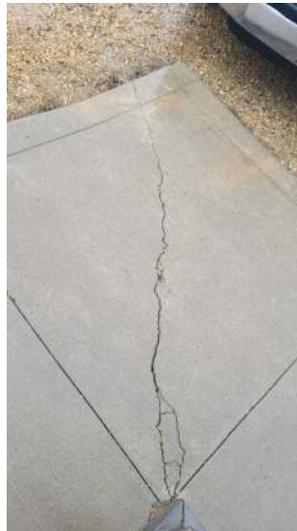
The sidewalks have typical cracks that indicate movement of the base under the sidewalk, water management needs to be addressed to control movement. If this is left it can effect the components of the building and surrounding areas.

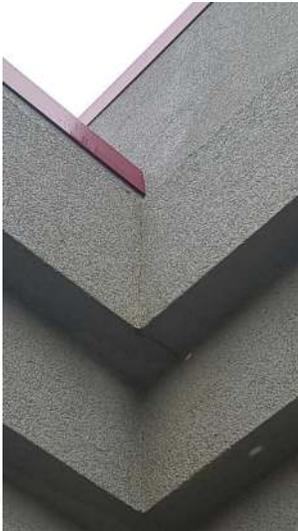
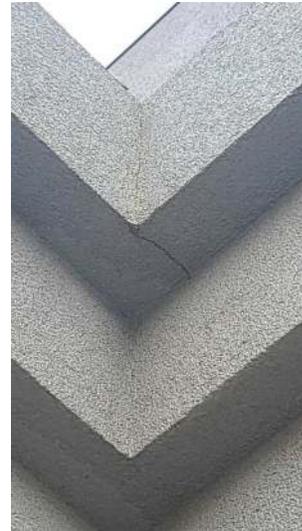
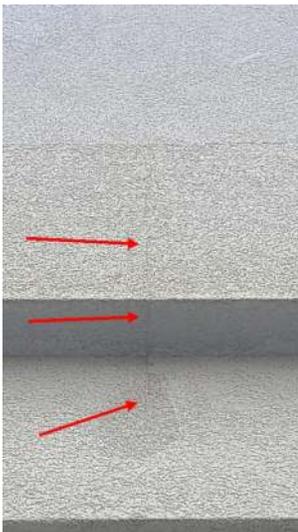
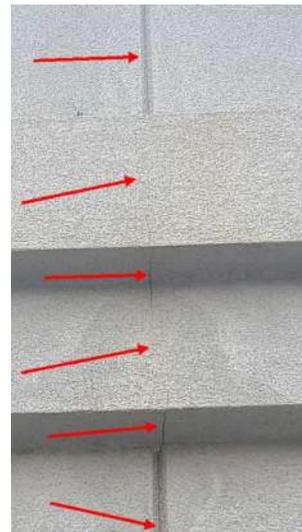
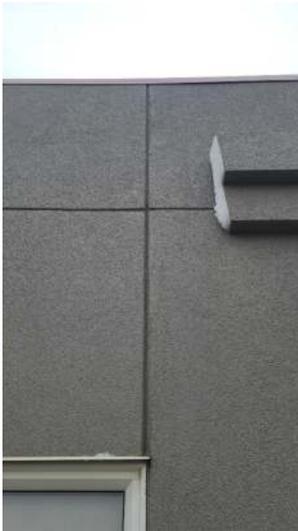
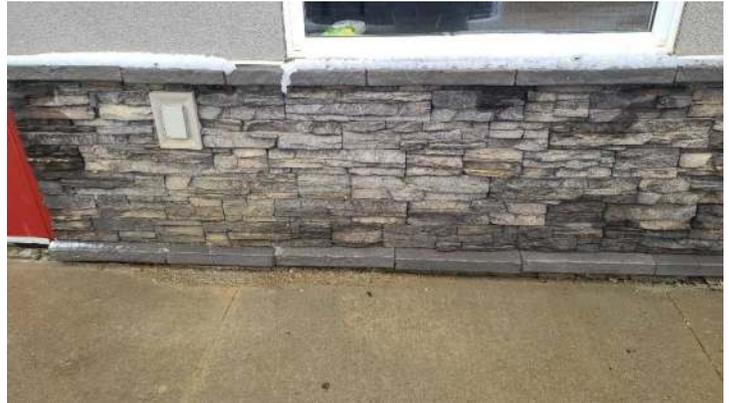
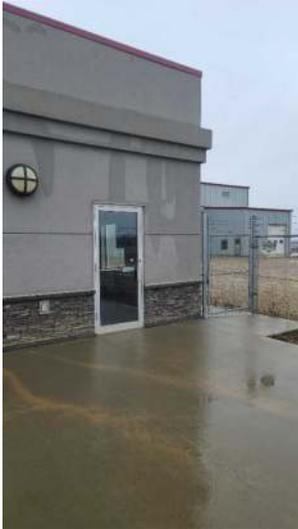
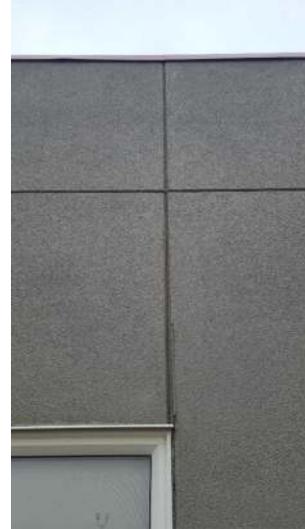
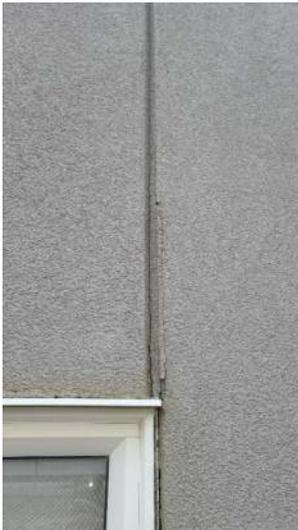
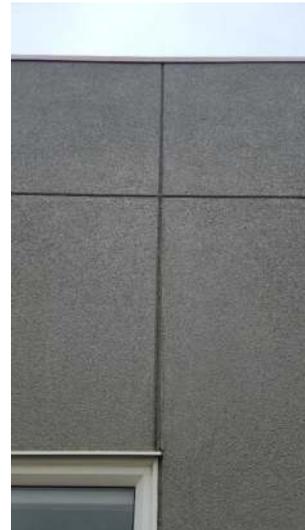
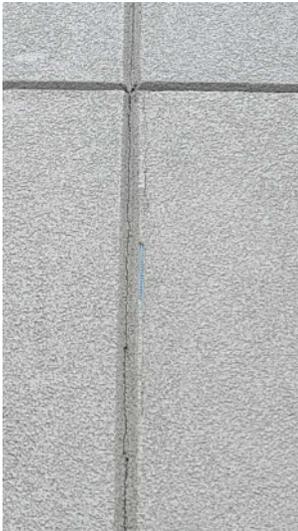
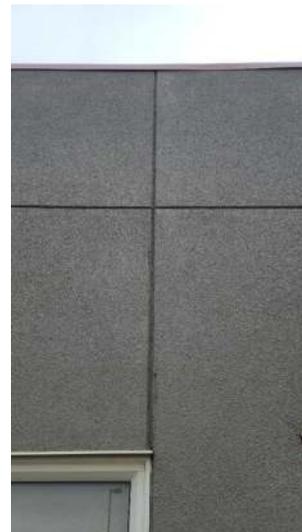
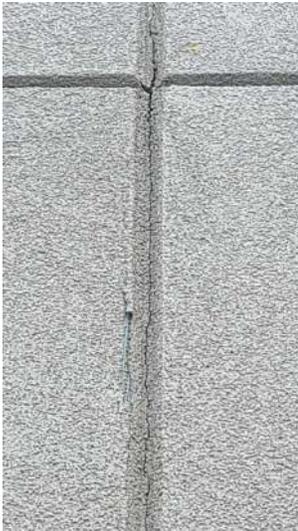
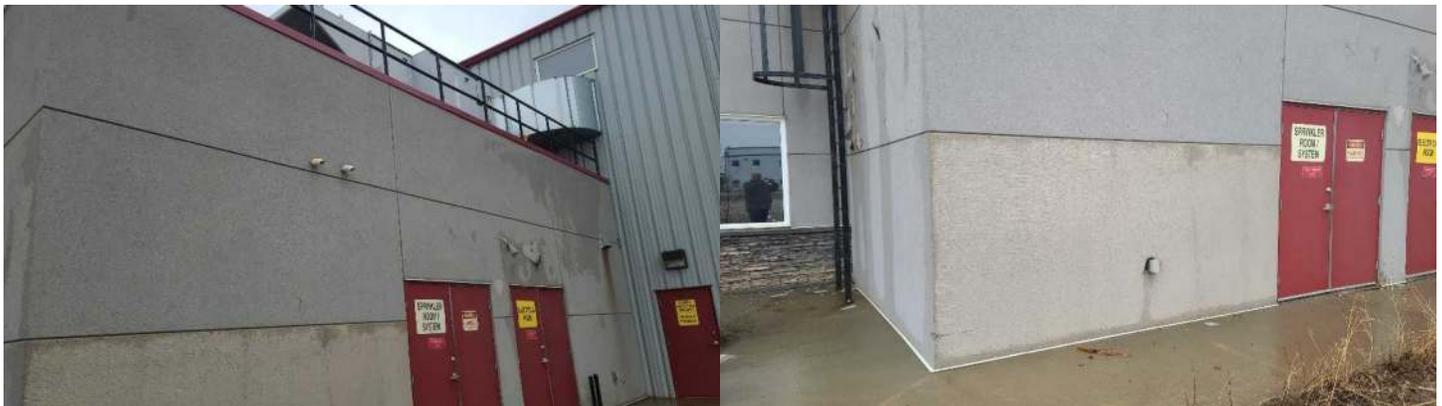
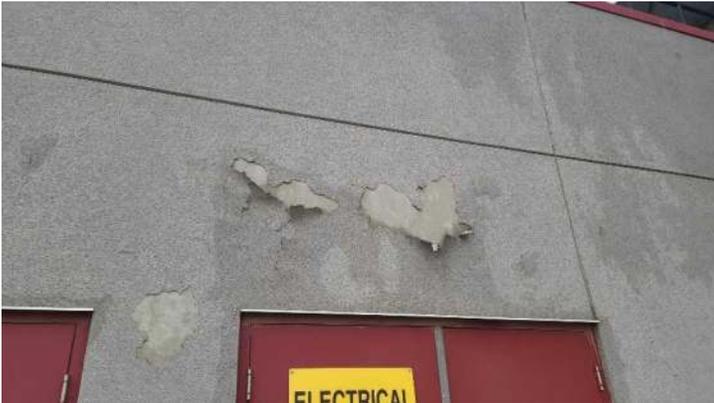
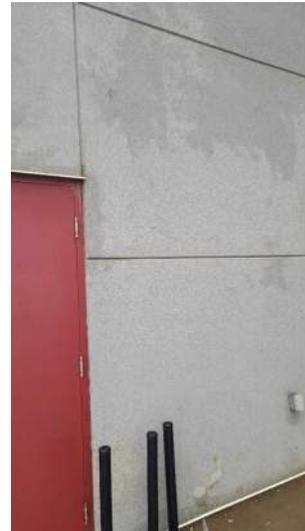
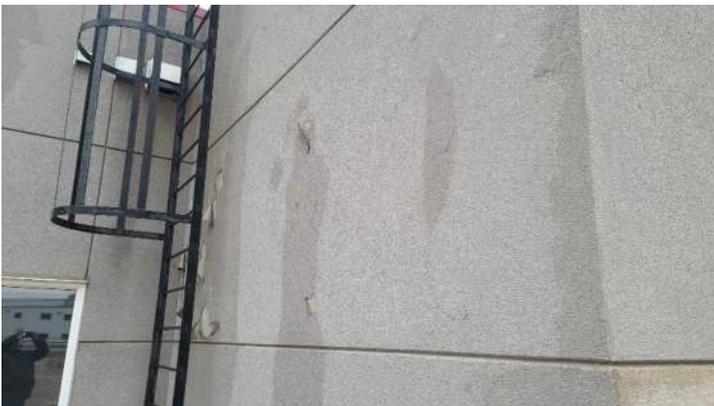
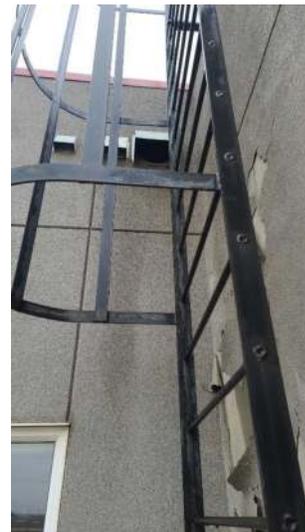
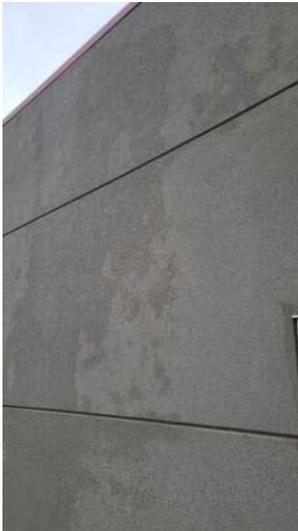
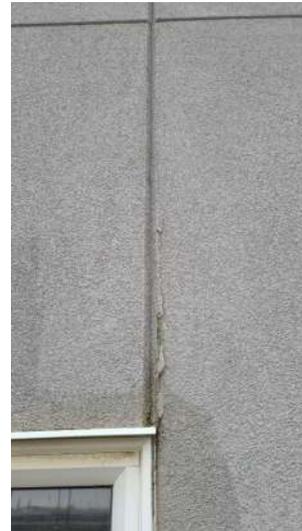
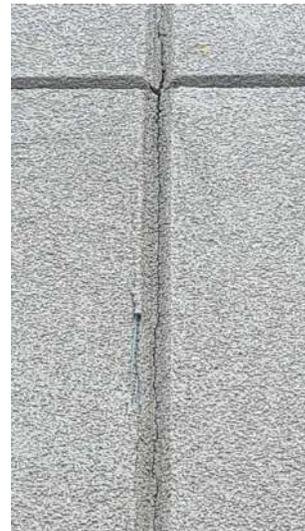
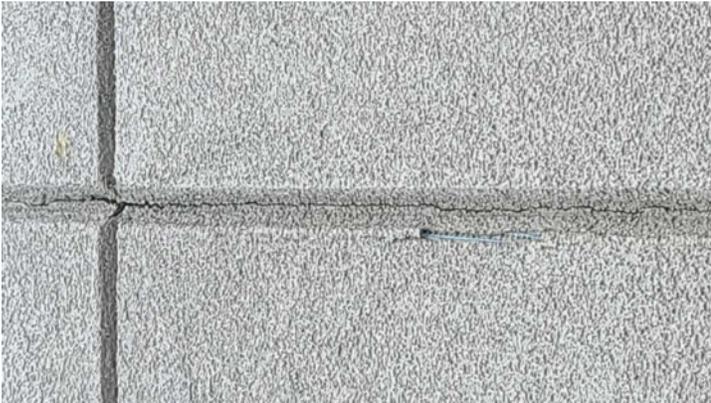
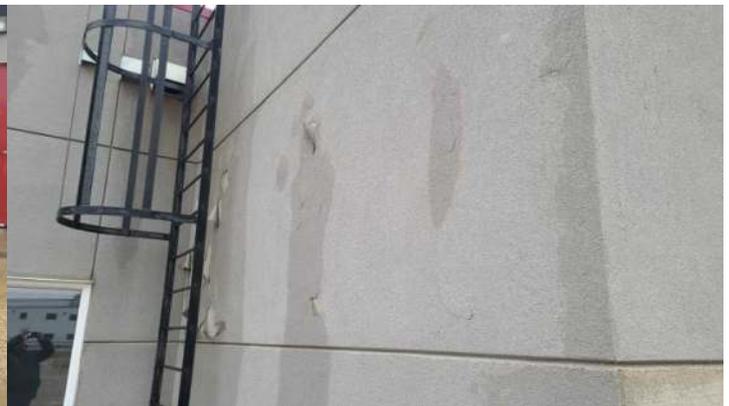
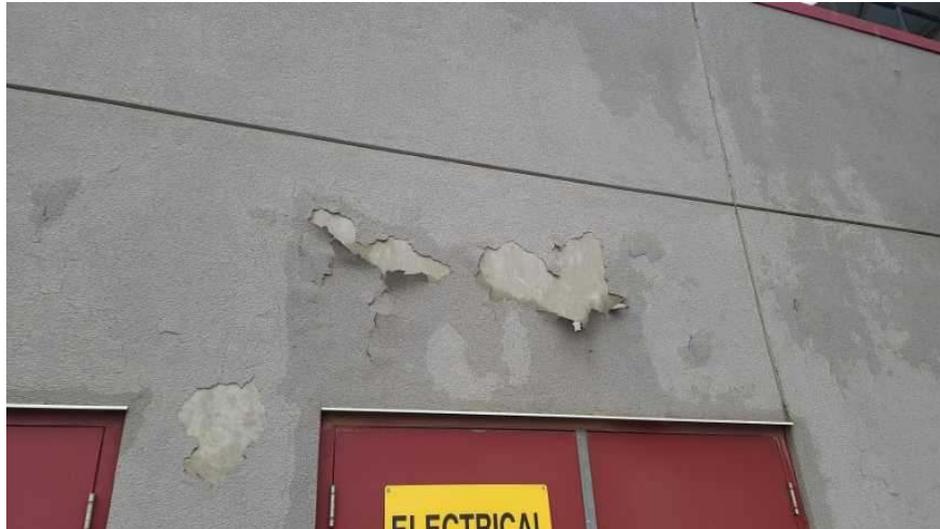
The EIFS wall covering is peeling and cracking, have a contractor evaluate and service as needed.

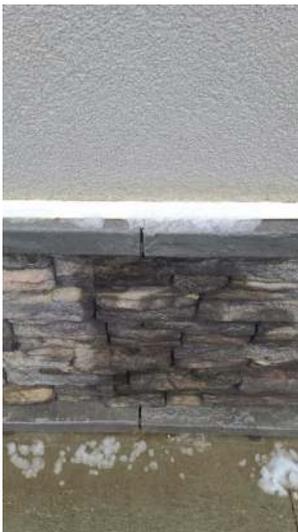
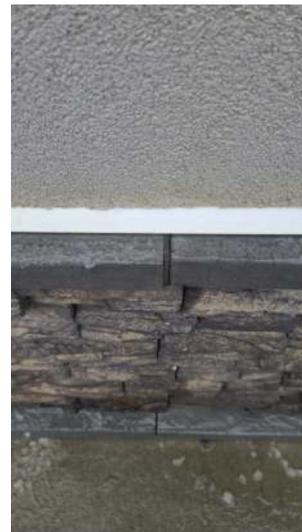
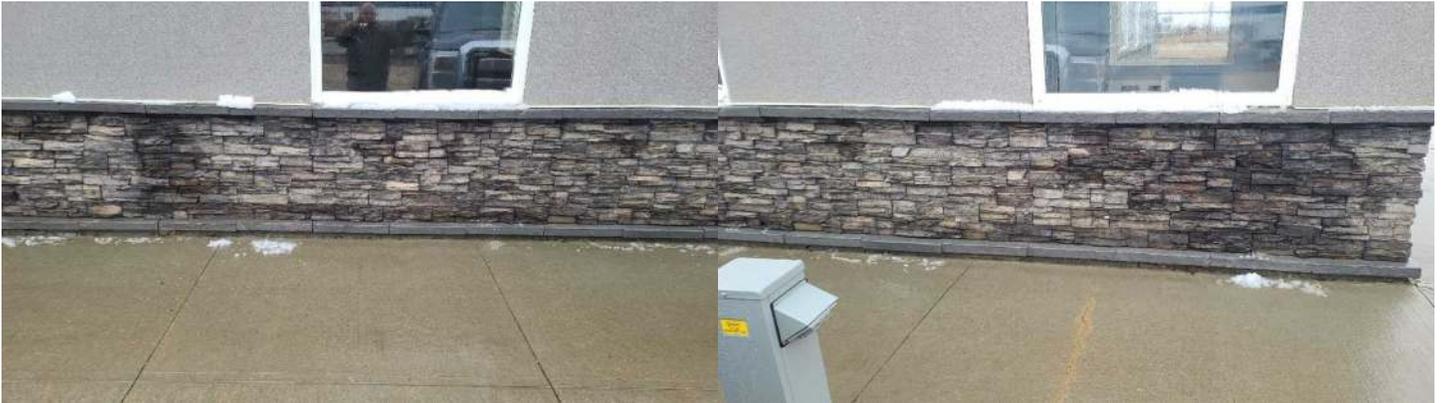
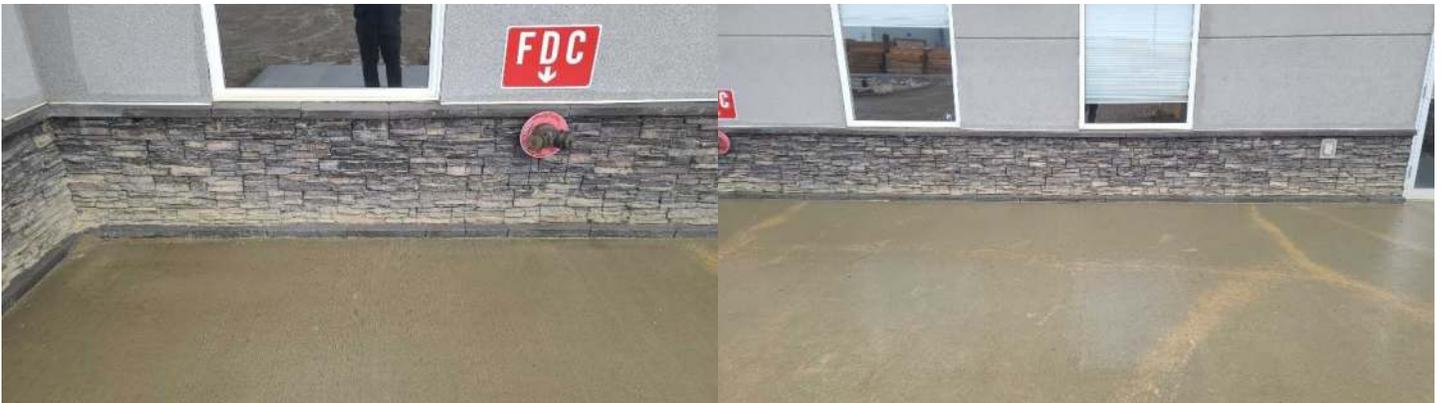
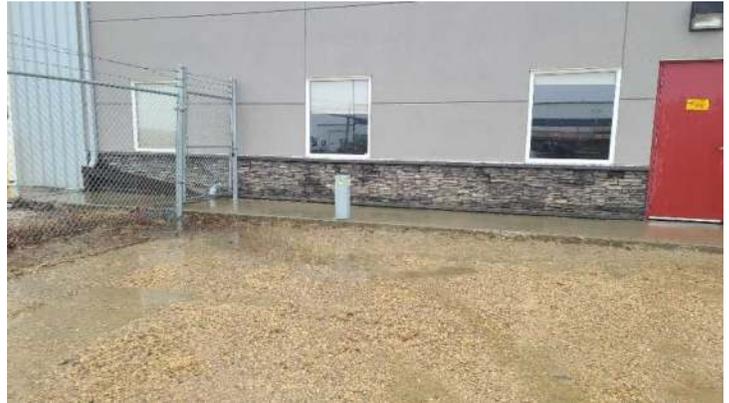
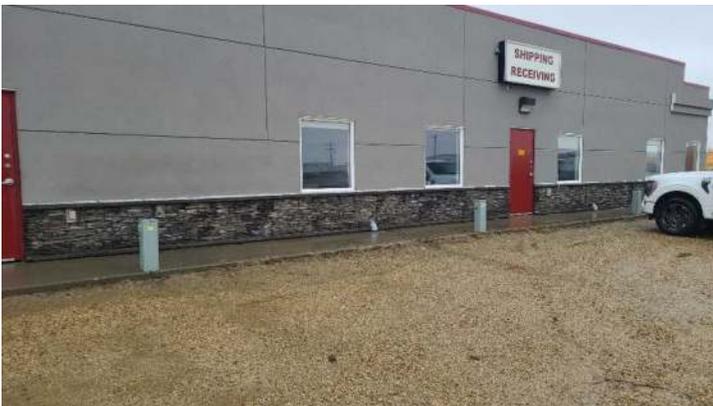
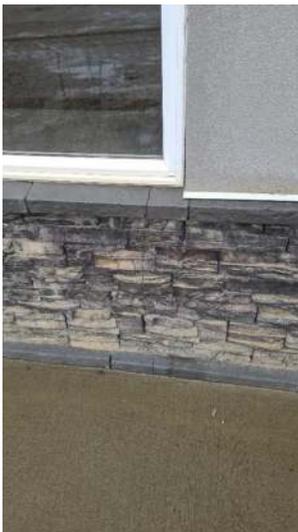
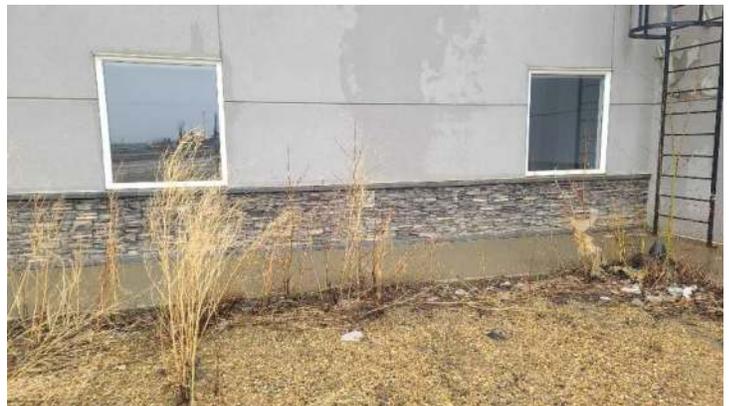
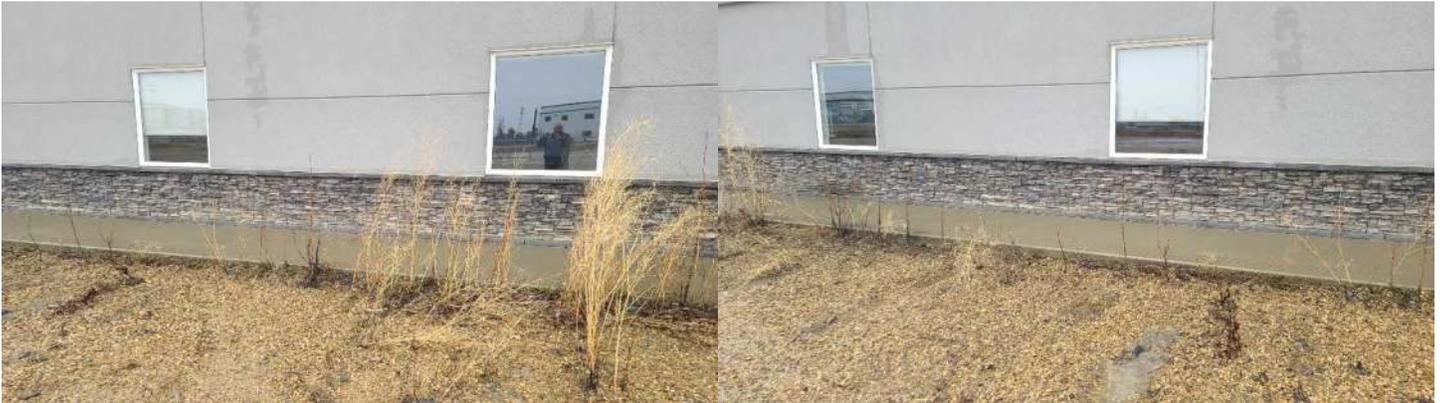
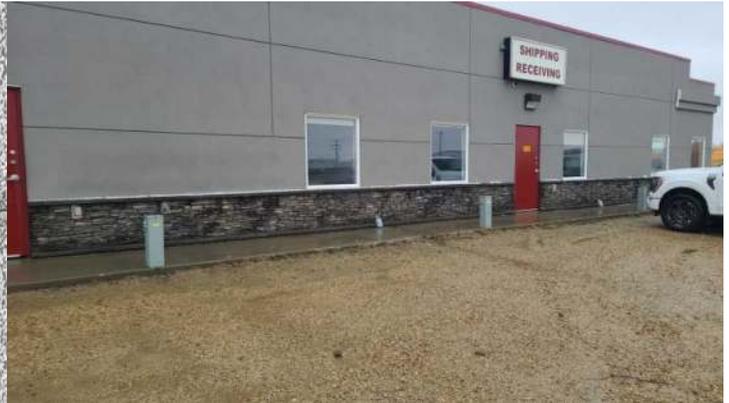
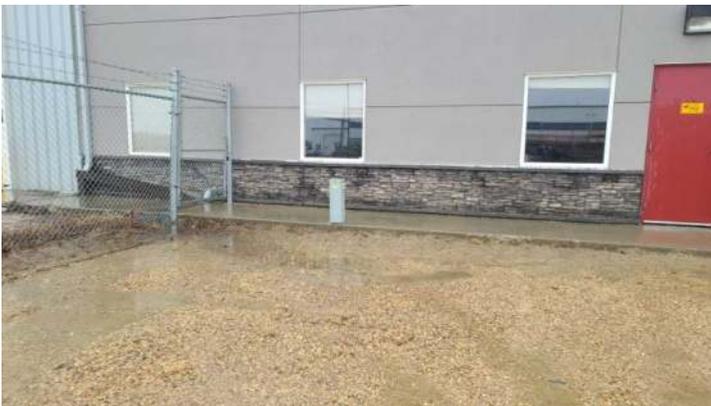
The stone veneer is very loose in places and will need to be serviced.

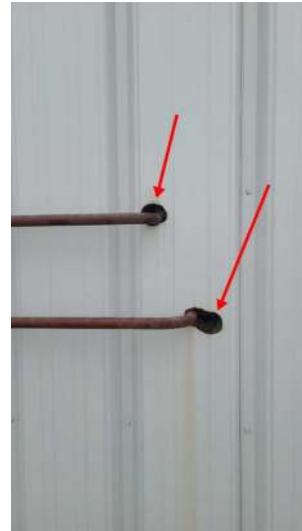
There are holes around some of the pipes in the warehouse area that need to be sealed.

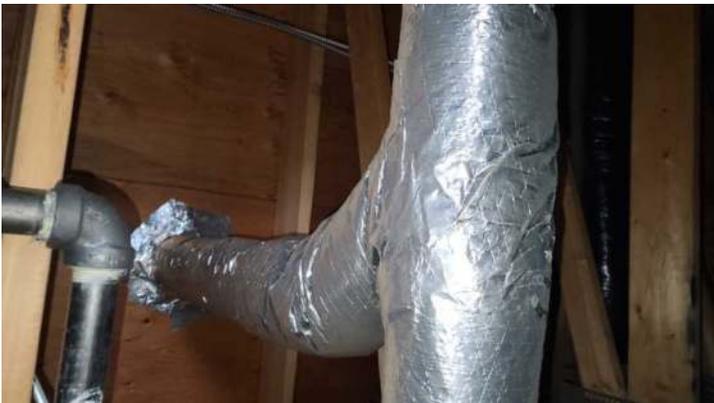
There are pipes penetrating thru the roof that need to be insulated inside to keep the hot and cold air away from each, if not serviced this can cause condensation damage to the the ceiling inside the building. Have a contractor evaluate and service as needed.

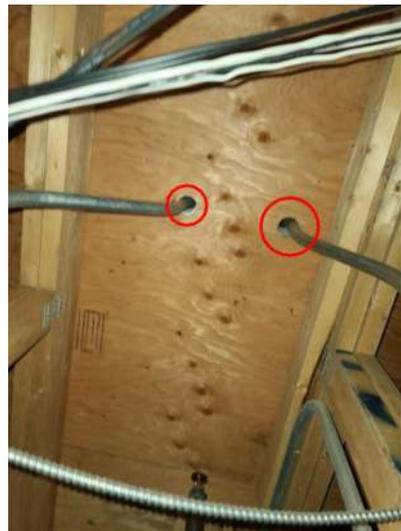
There are pipes penetrating thru the roof that need to be insulated inside to keep the hot and cold air away from each, if not serviced this can cause condensation damage to the the ceiling inside the building. Have a contractor evaluate and service as needed.

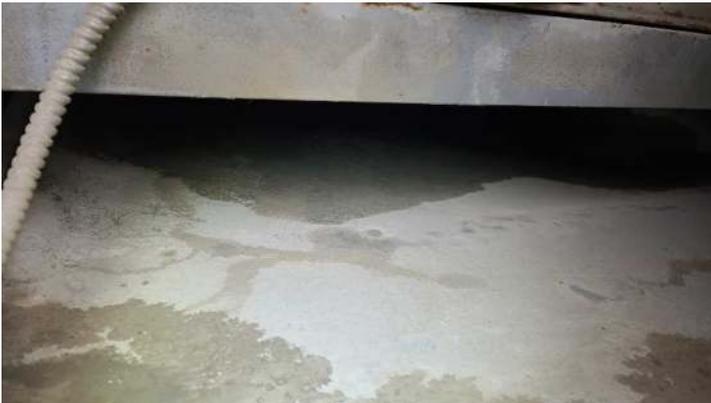
The exhaust systems are very dirty and should be serviced by a contractor accordingly.

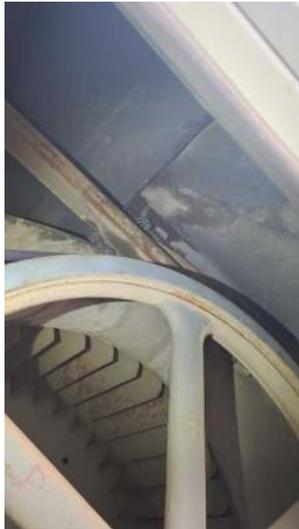
The exhaust system for the warehouse area has a few leaking that should be serviced by a contractor.

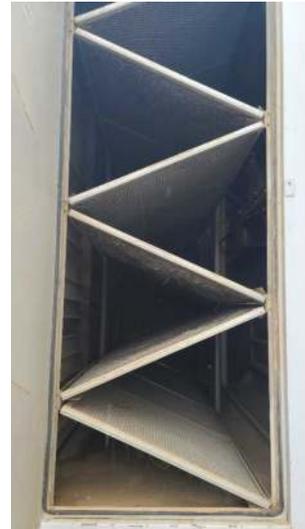
The exhaust systems are very dirty and should be serviced by a contractor accordingly.

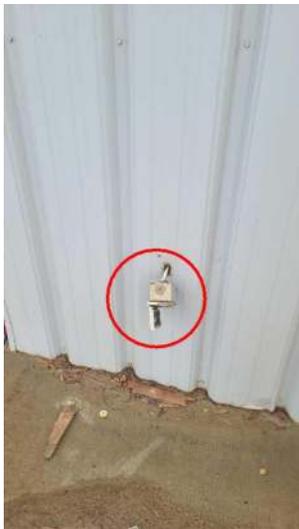
There are loose outlets on the outside of the building, have an electrician service these accordingly

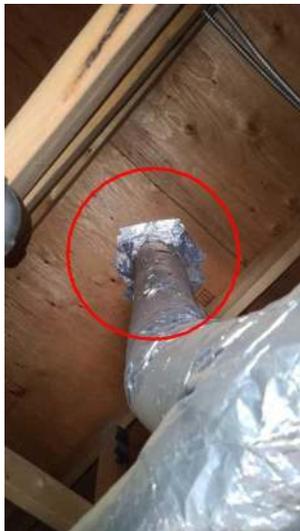
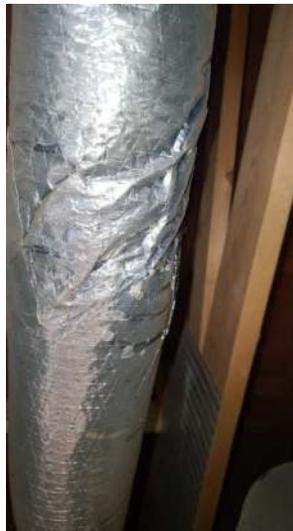
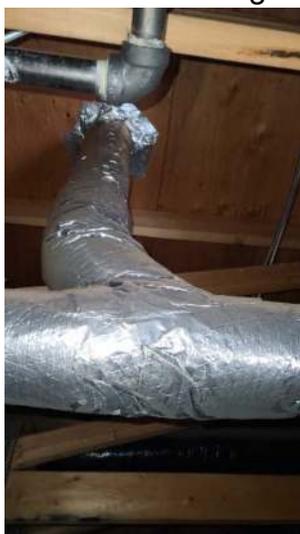
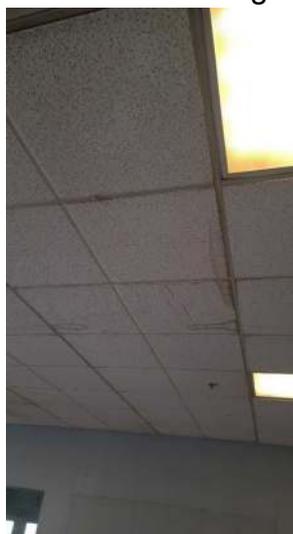
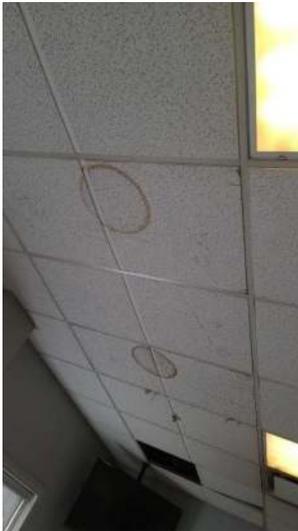
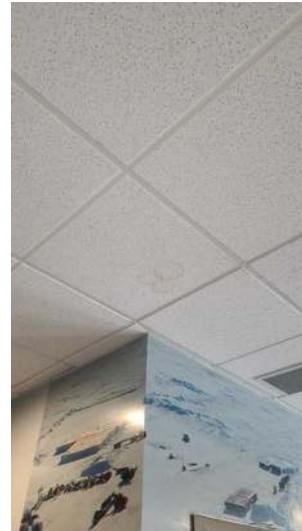
There are signs of moisture in the building that should be monitored, with the grading and drainage being poor this is a problem that may continue. A contractor should be used to evaluate the property and how to keep the moisture away from the building.

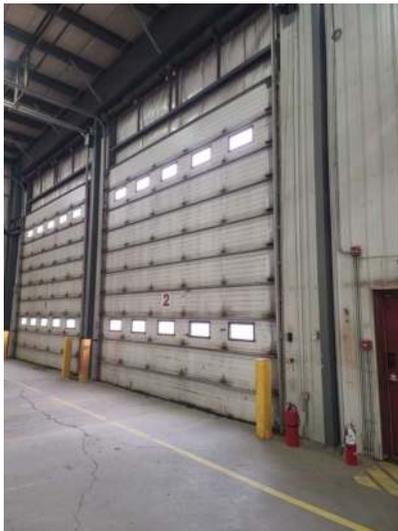
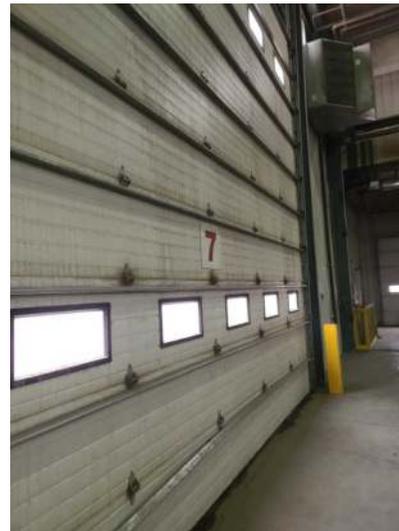
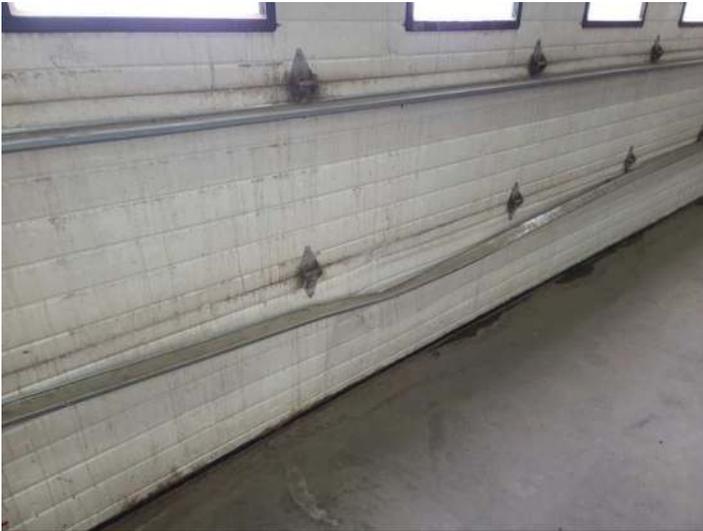
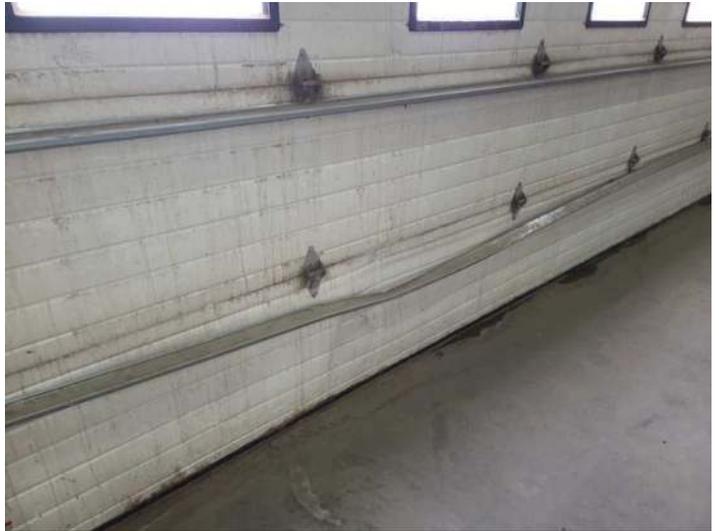
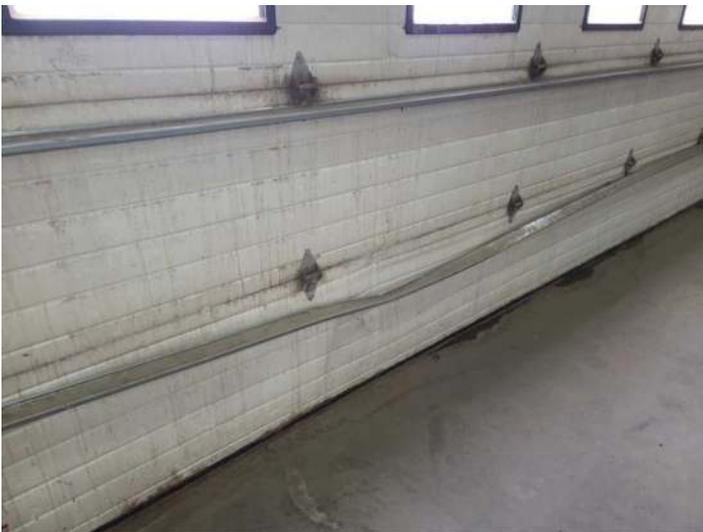
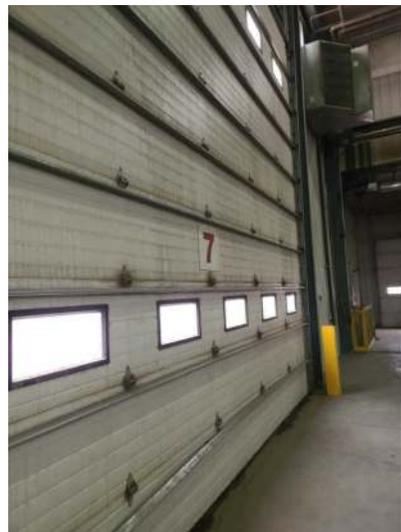
There are multiple doors that are damaged, you may want to have a contractor evaluate and service as needed . They were functional at the time of the inspection, but you may have issues if not serviced.

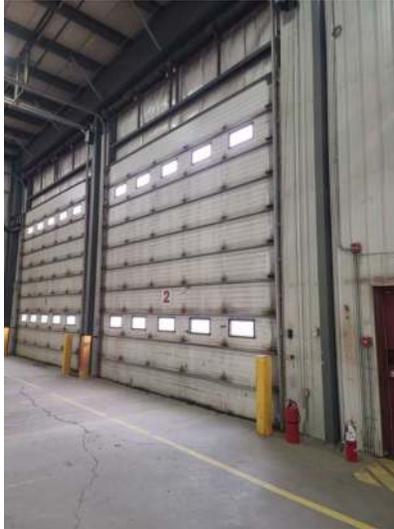
There are two doors that did not functional correctly or at all, they are doors 2 and 3. Have a contractor evaluate and service these doors.
